CONSULTING SERVICES FOR DESIGN AND WORKS SUPERVISION OF 10 BRIDGES IN DOBROGEA AREA

B08-BRIDGE A2 BORCEA

TD - B08 - 02

A3
GUARD RAIL REPLACEMENT

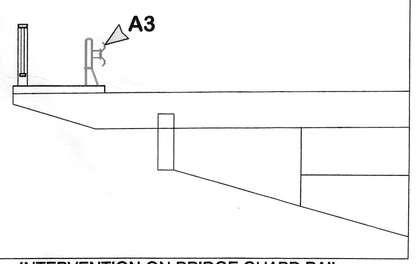
INTERVENTION ON BRIDGE GUARD RAIL - 1:50

Inadequate height and corroded guard rail

Replacement of all bridge guard rail on both carriageways

It needs to dismantle existing guard rail and assembling the new one with the following operations:
- removal of the guard rail connection screws;
- cutting with oxyacetylene flame of the posts;
- loading and transport of the material resulting from the demolition to an approved dump area.
- procurement, transport, storage and handling of the guard rail elements and other related materials and equipment;
- local transport and handling of the guard rail elements;
- assembling of the guard rail elements;
- supply and installation of the reflective elements;
- rust protective paint;
- final paint in two layers;
- verifications after execution in accordance to the design;
- sampling and laboratory testing;

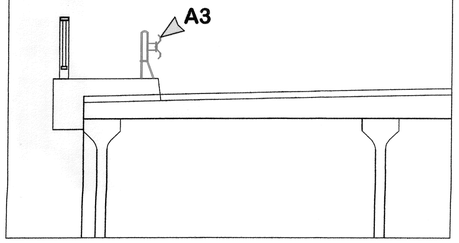
INTERVENTION ON VIADUCT GUARD RAIL - 1:50

Replacement of all viaduct guard rail on both carriageways
