CONSULTING SERVICES FOR DESIGN AND WORKS SUPERVISION OF 10 BRIDGES IN DOBROGEA AREA

B08-BRIDGE A2 BORCEA

TD - B08 - 09

C1
DECK SLAB REPAIR

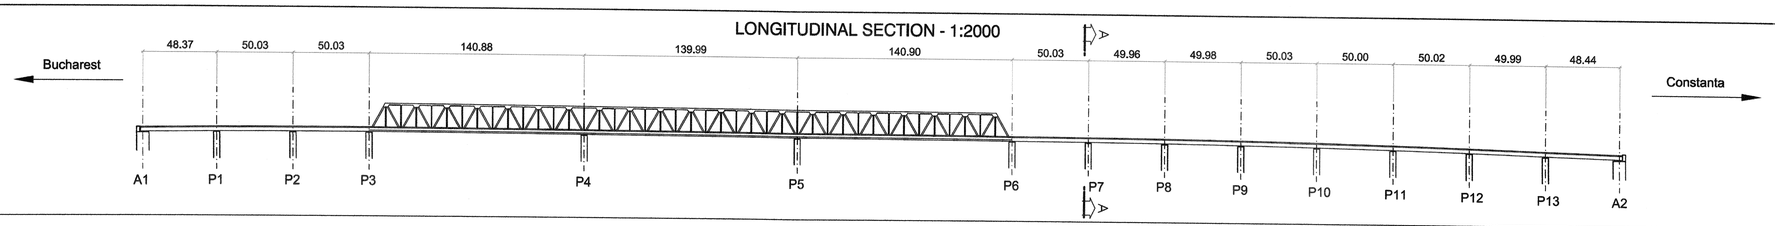
Efflorescence on underdeck slab

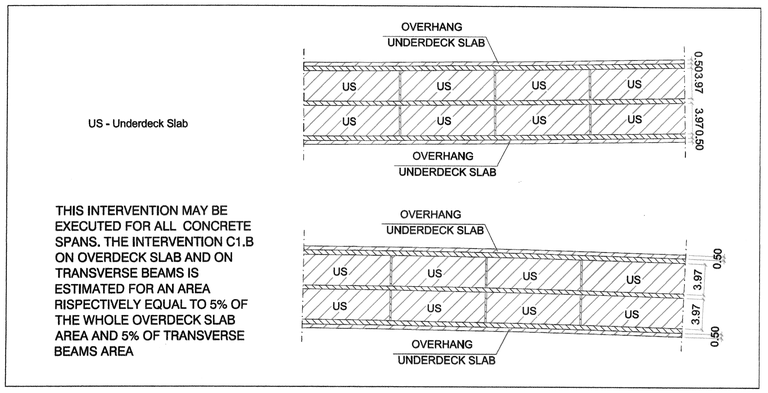
INTERVENTION ON VIADUCT CONCRETE DECK SLAB AND TRANSVERSE BEAMS - 1:100

THIS INTERVENTION MAY BE EXECUTED FOR ALL CONCRETE SPANS. THE INTERVENTION C1.B ON OVERDECK SLAB AND ON TRANSVERSE BEAMS IS ESTIMATED FOR AN AREA RISPECTIVELY EQUAL TO 5% OF THE WHOLE OVERDECK SLAB AREA AND 5% OF TRANSVERSE BEAMS AREA

INTERVENTION C1.A SEQUENCE - INT C1.A :
1 - Sounding of concrete to locate areas of deterioration (spalling, honeycomb, corrosion);
2 - Concrete sand blast cleaning to prepare the surface for receiving protective materials;
3 - Concrete water washing with 1500 psi of pressure to remove oils, grease or other substances;
4 - Application of an epoxy resin primer coat like MASTERSEAL PRIMER PU from BASF or similar;
5 - Application of a polyurethane resin protective coat like MASTERSEAL FORMULA PU from BASF or similar;

INTERVENTION C1.B SEQUENCE - INT C1.B :
1 - Sounding of concrete to locate areas of deterioration (spalling, honeycomb, corrosion);
2 - Hydrodemolition of damaged concrete with 30000 psi of pressure and concrete removal of 4 cm, being atention with reinforcing steel;
3 - Concrete water washing with 1500 psi of pressure to remove oils, grease or other substances;
4 - Application of a modified polymer cementitious monocompound corrosion inhibitor like EMACO NANOCONCRETE AP from BASF or similar;
5 - Application of a thixotropic cementitious mortar with restrained expansion, fiber-reinforced with flexible inorganic fibres, like EMACO FORMULA TIXOFIBER from BASF or similar;
6 - Application of an epoxy resin primer coat like MASTERSEAL PRIMER PU from BASF or similar;
7 - Application of a polyurethane resin protective coat like MASTERSEAL FORMULA PU from BASF or similar;
