INTERVENTION WORK: D3- STRENGTHEN OF ANCHOR BOLTS

CONSULTING SERVICES FOR DESIGN AND WORKS SUPERVISION OF 10 BRIDGES IN DOBROGEA AREA

B08-BRIDGE A2 BORCEA

TD - B08 - 14

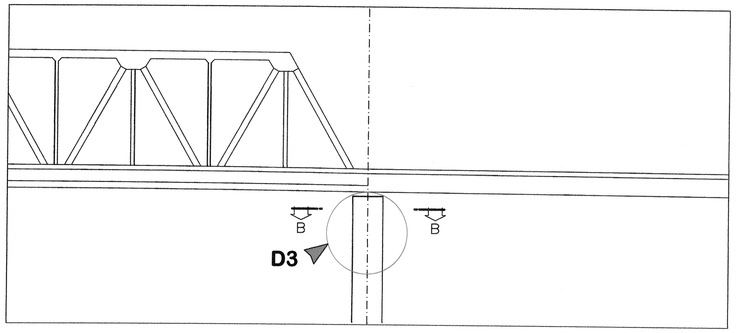
INTERVENTION ON P3 ANCHOR BOLTS - 1:250

Missing anchor bolts

The item covers the following activities:
- procurement, transport,storage and handling of related materials and equipment;
- restore missing anchor bolts in the connections;
- check anchor bolts for adequate attachment.
