INTERVENTION WORK: C1- DECK SLAB REPAIR

B07-BRIDGE A2 CERNAVODA

TD - B07 - 09

C1
DECK SLAB REPAIR

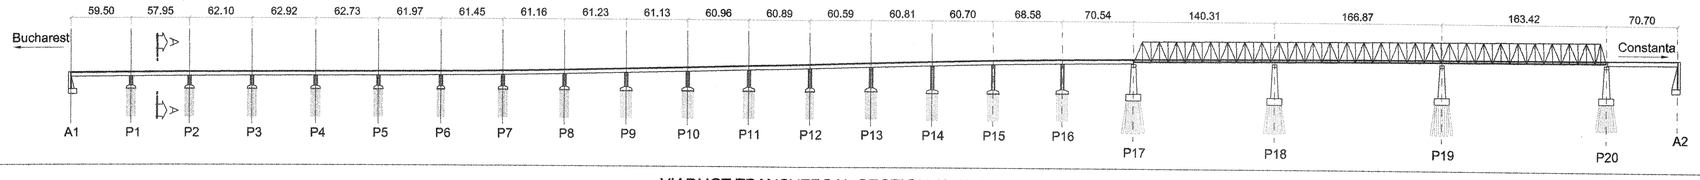
DETERIORATION:

Efflorescence ans spalling on overhang underdeck slab

Spalling and lack of concrete cover on overhang underdeck slab

INTERVENTION C1.A SEQUENCE - INT C1.A :
1 - Sounding of concrete to locate areas of deterioration (spalling, honeycomb, corrosion);
2 - Concrete sand blast cleaning to prepare the surface for receiving protective materials;
3 - Concrete water washing with 1500 psi of pressure to remove oils, grease or other substances;
4 - Application of an epoxy resin primer coat like MASTERSEAL PRIMER PU from BASF or similar;
5 - Application of a polyurethane resin protective coat like MASTERSEAL FORMULA PU from BASF or similar;

INTERVENTION C1.B SEQUENCE - INT C1.B :
1 - Sounding of concrete to locate areas of deterioration (spalling, honeycomb, corrosion);
2 - Hydrodemolition of damaged concrete with 30000 psi of pressure and concrete removal of 4 cm, being atention with reinforcing steel;
3 - Concrete water washing with 1500 psi of pressure to remove oils, grease or other substances;
4 - Application of a modified polymer cementitious monocompound corrosion inhibitor like EMACO NANOCONCRETE AP from BASF or similar;
5 - Application of a thixotropic cementitious mortar with restrained expansion, fiber-reinforced with flexible inorganic fibres, like EMACO FORMULA TIXOFIBER from BASF or similar;
6 - Application of an epoxy resin primer coat like MASTERSEAL PRIMER PU from BASF or similar;
7 - Application of a polyurethane resin protective coat like MASTERSEAL FORMULA PU from BASF or similar;

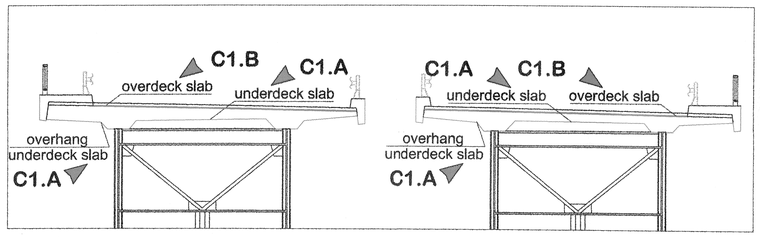
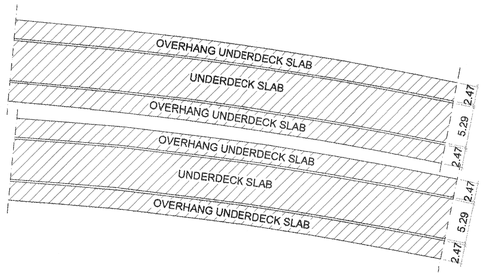
INTERVENTION ON VIADUCT CONCRETE DECK SLAB - 1:100

THIS INTERVENTION MAY BE EXECUTED FOR ALL CONCRETE SPANS. THE INTERVENTION C1.B ON OVERDECK SLAB IS ESTIMATED FOR AN AREA EQUAL TO 5% OF THE WHOLE OVERDECK SLAB AREA.
